PEDESTRIAN SAFE CORRIDORS: MEMORANDUM

This memorandum contains a brief analysis of the pedestrian crashes pre- and post-improvement along three corridors in New Jersey: downtown Newark (Market and Ferry Sts); Route 27 in Elizabeth, Roselle, and Linden; and Route 70 in Cherry Hill. The data analyzed come from CAIT's Plan4Safety database of reported automobile crashes involving pedestrians from January 2003 to May 2011. In summary, we found that pedestrian improvements may have been a factor in reducing pedestrian crashes in the dense urban area of downtown Newark where mixed pedestrian-automobile traffic is more common. In more suburban locations like Route 27 and especially Route 70, the evidence is inconclusive.

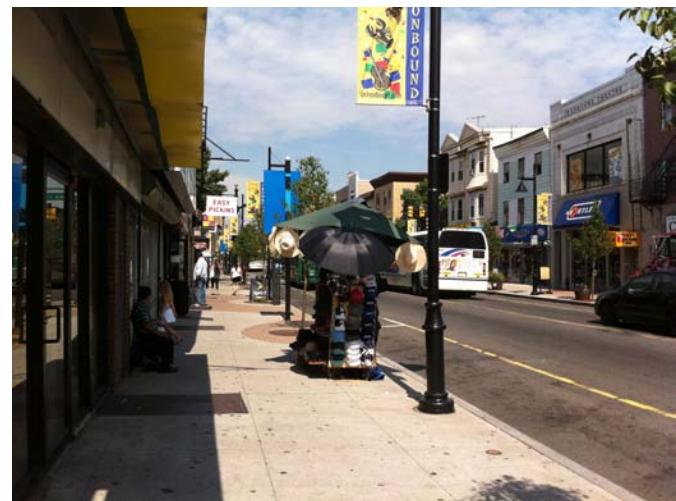
Figure 1: Streetscape improvements along Ferry Street in the Ironbound neighborhood of Newark, New Jersey

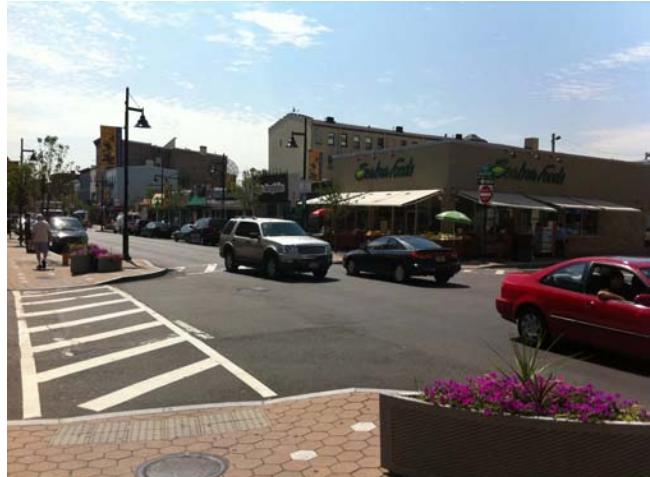
Figure 2: Uncontrolled intersection in downtown Newark

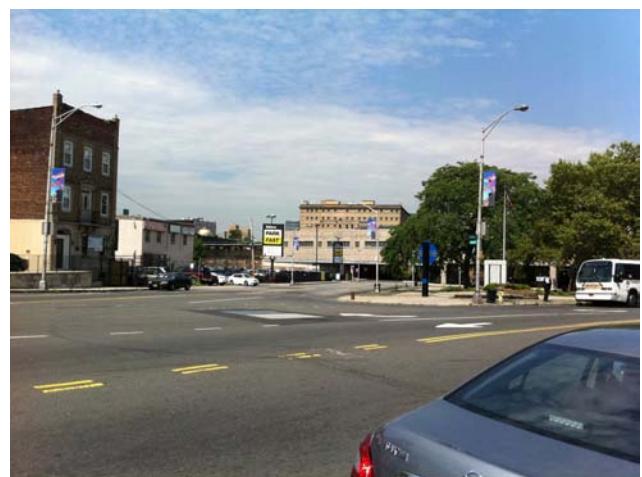
Figure 3: Ferry St near the north end of the corridor: Less pedestrian friendly environment.

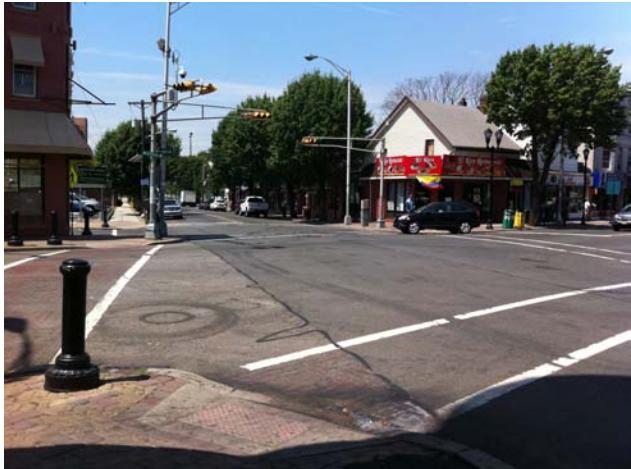
Figure 4: Improvements in downtown Elizabeth along Route 27

We observed minimal improvements in our field visit along Route 27. Downtown Elizabeth had some road striping, signage, and ADA textured ramps, but pedestrian signals were missing at all crossings. In fact, several intersections had no visible signals at all (auto

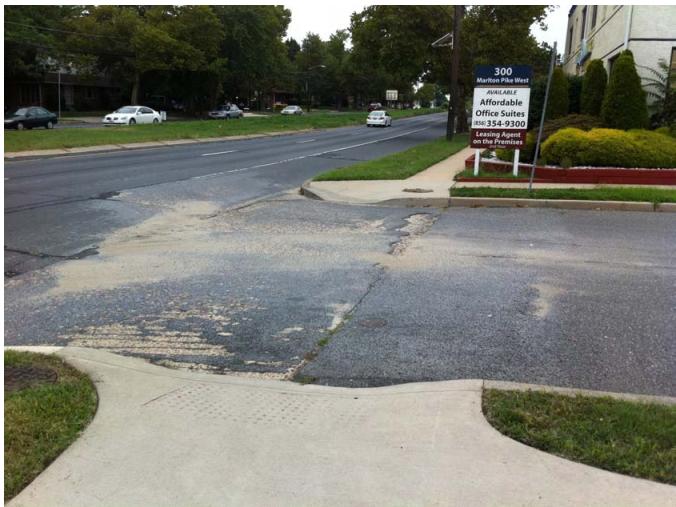
Figure 5: Limited improvements along Route 70 in Cherry Hill.

Field observation detected very little improvement along the Route 70 corridor, although some photos provided to us show the installation of sidewalks in the corridor (see Appendix B). No striping, signs or signals were observed along the corridor. This may be due to the age of the potential improvements; they were made over 5 years ago. The overall pedestrian environment as observed during our field trip was poor.

Numerous driveways, limited crossing zones, and high speeds on Route 70 make this an uninviting place for pedestrians. Large scale improvements would be necessary to address all the potential conflicts along this corridor. We observed very little pedestrian activity along this corridor during our early afternoon field visit.

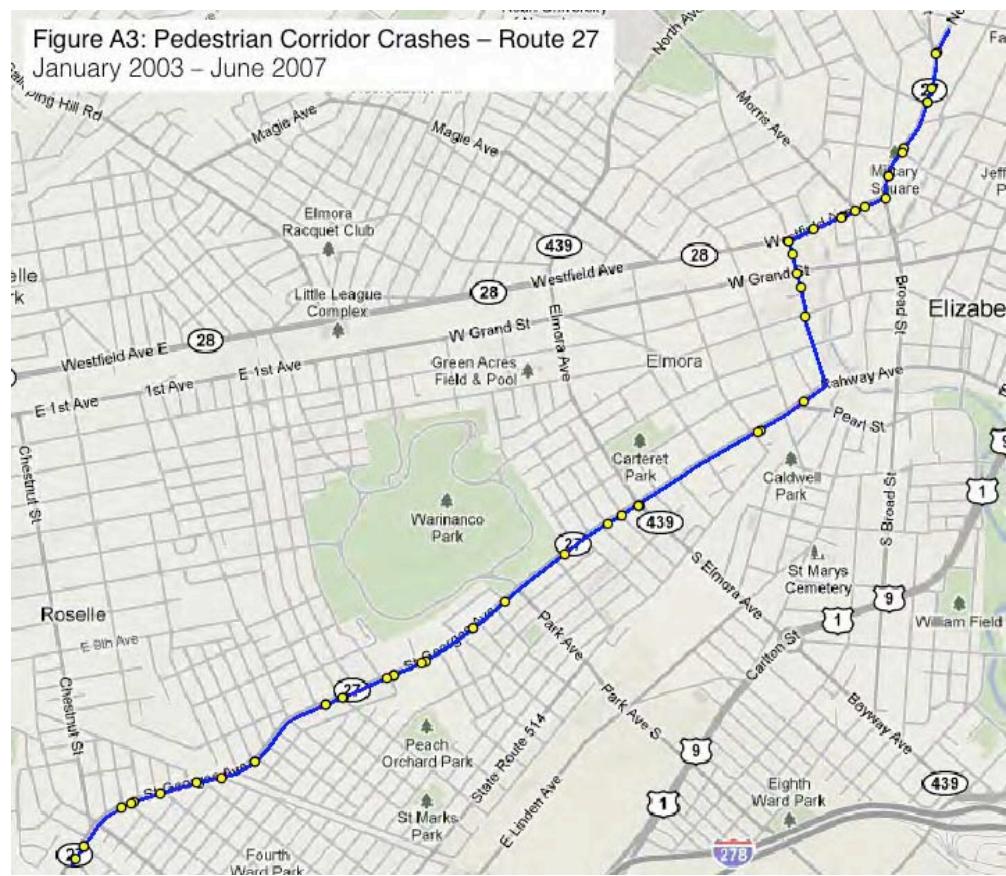
Route 27 in Union County had pedestrian improvements completed in July, 2007 along a 3.9-mile corridor. Appendix figures A-3 and A-4 map the pre- and post-improvement crashes along the study corridors in downtown Elizabeth and the rest of the corridor. From August, 2007, to April, 2011, this corridor had 46 reported pedestrian crashes (1 fatal), or about 1.0 per month. Prior to improvement, reported crashes along this corridor totaled 55 (2 fatal) from January, 2003, to July 2007, or about 1.0 crashes per month. The limited nature of these data—especially without information on specific improvements—make the reported results inconclusive. The spatial data presented in Figures A-3 and A-4, though, show a decrease in crashes in the dense downtown Elizabeth area along Westfield Avenue.

Figure A3: Pedestrian Corridor Crashes – Route 27
January 2003 – June 2007

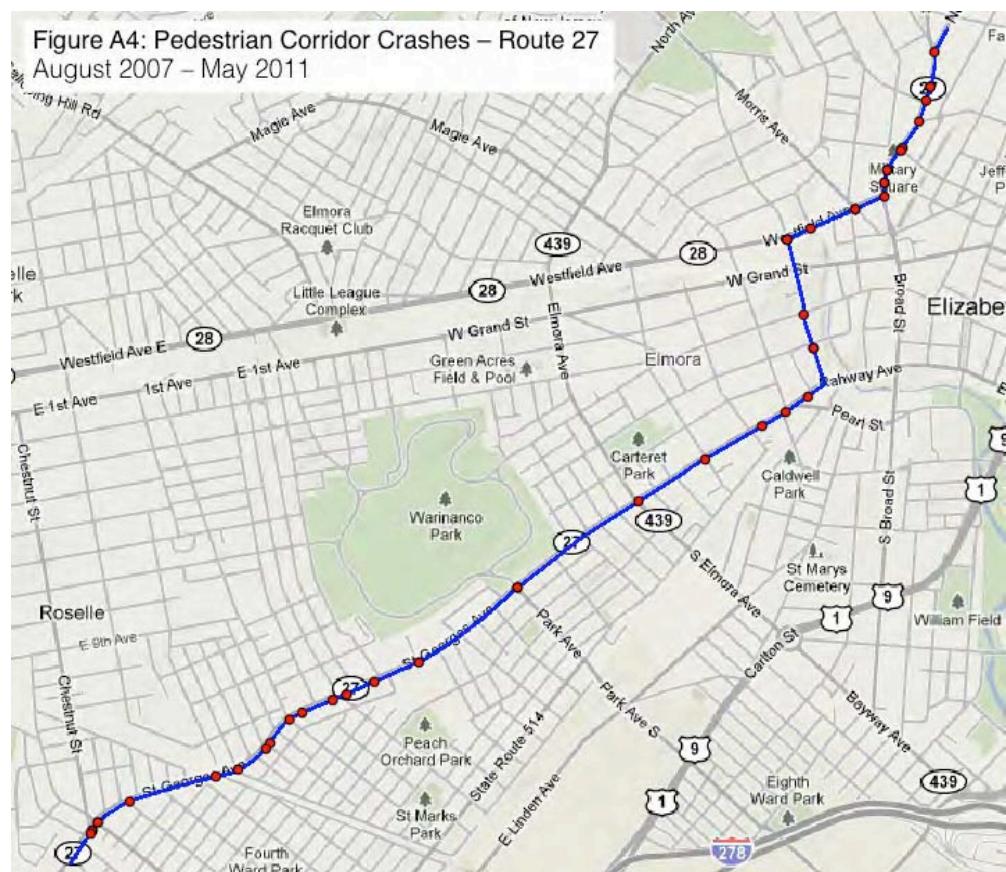
Figure A4: Pedestrian Corridor Crashes – Route 27
August 2007 – May 2011

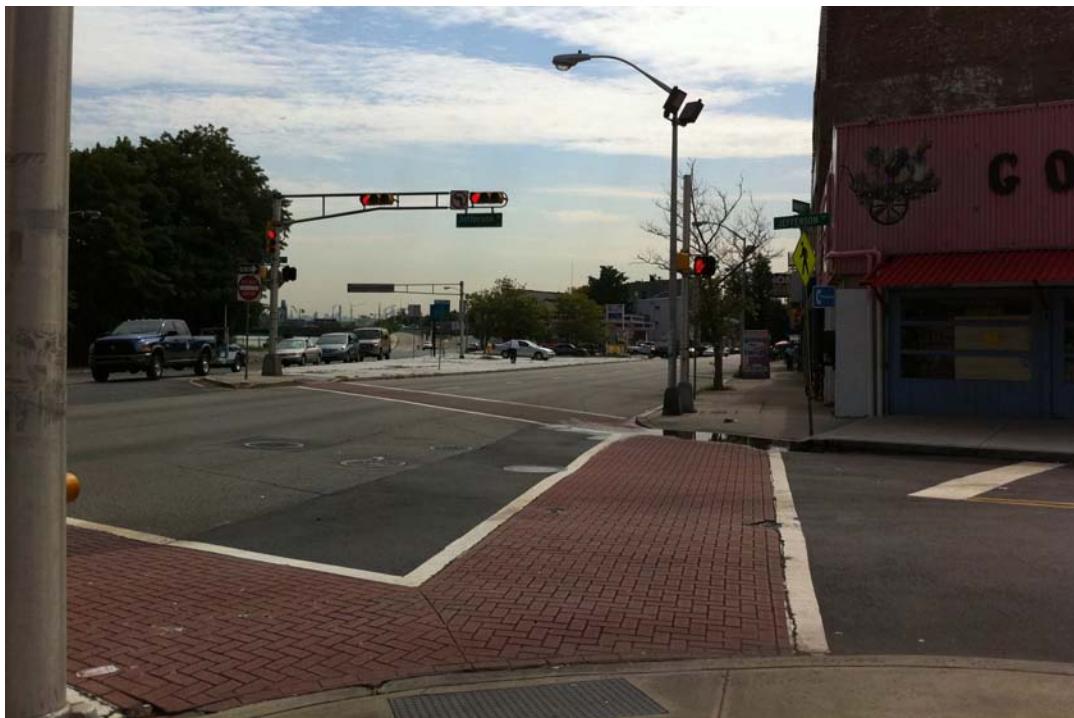
Figure B1 – Improvements along Market Street consist of mainly striping, ADA sidewalk ramps, and pedestrian crossing signs.

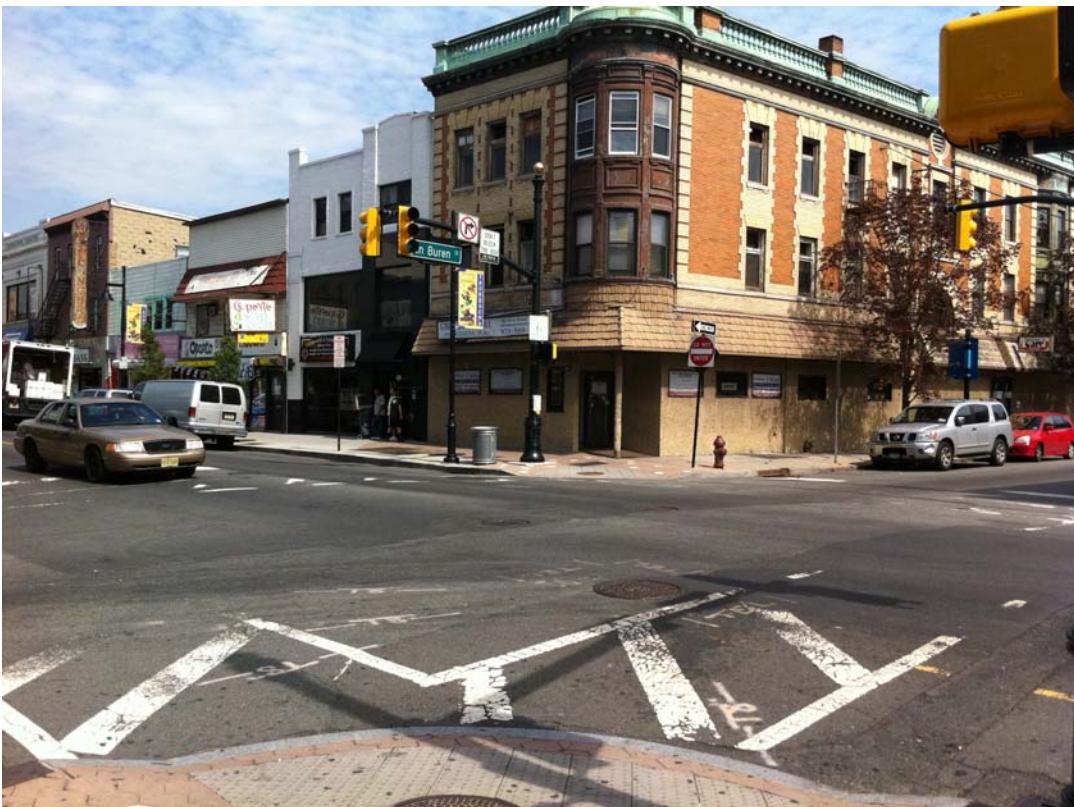
Figure B2 – Van Buren St & Ferry St – More substantial improvements along Ferry Street, but road striping has not been maintained.

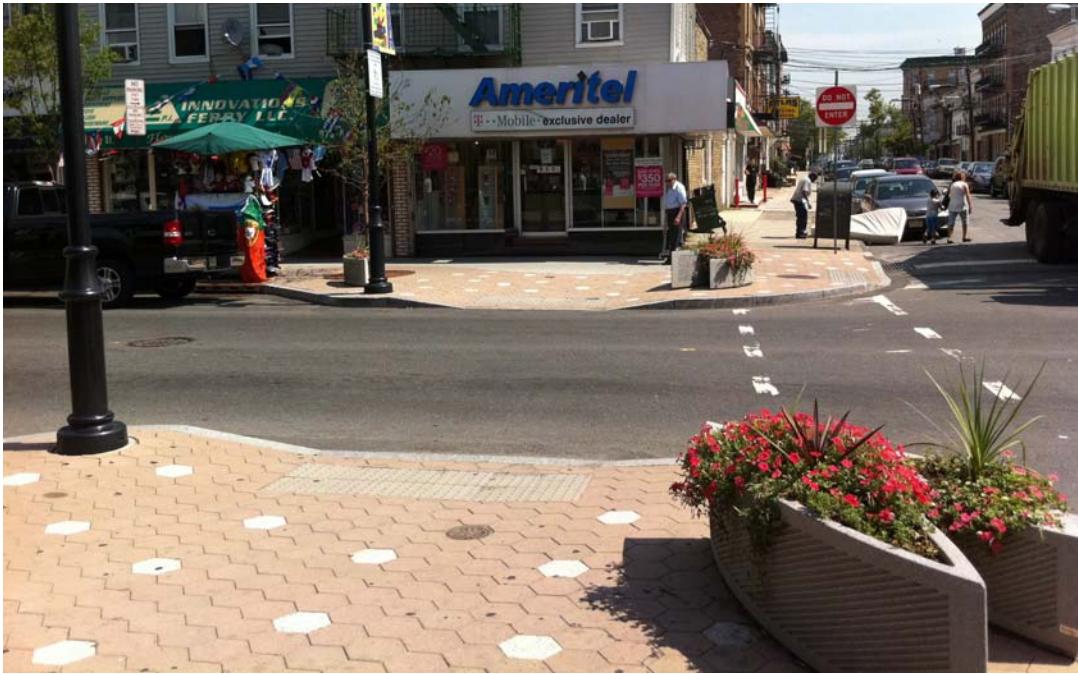
Figure B3 – Monroe St & Ferry St – Greatly improved sidewalk aesthetic quality and planters along Ferry Street. Curb bump outs make crossing safer, but intersection is still uncontrolled.

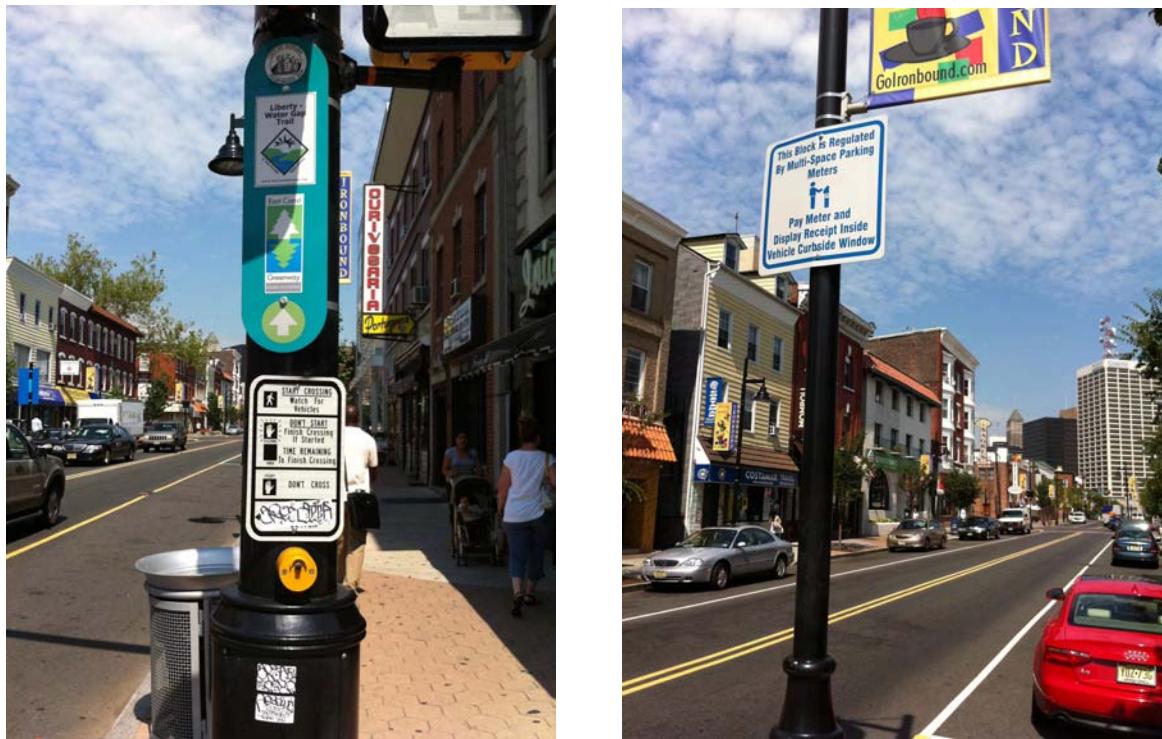
Figures B4 & B5 – Pedestrian and parking signs have been improved along the corridor; parking meters have been replaced with electronic collection kiosks.

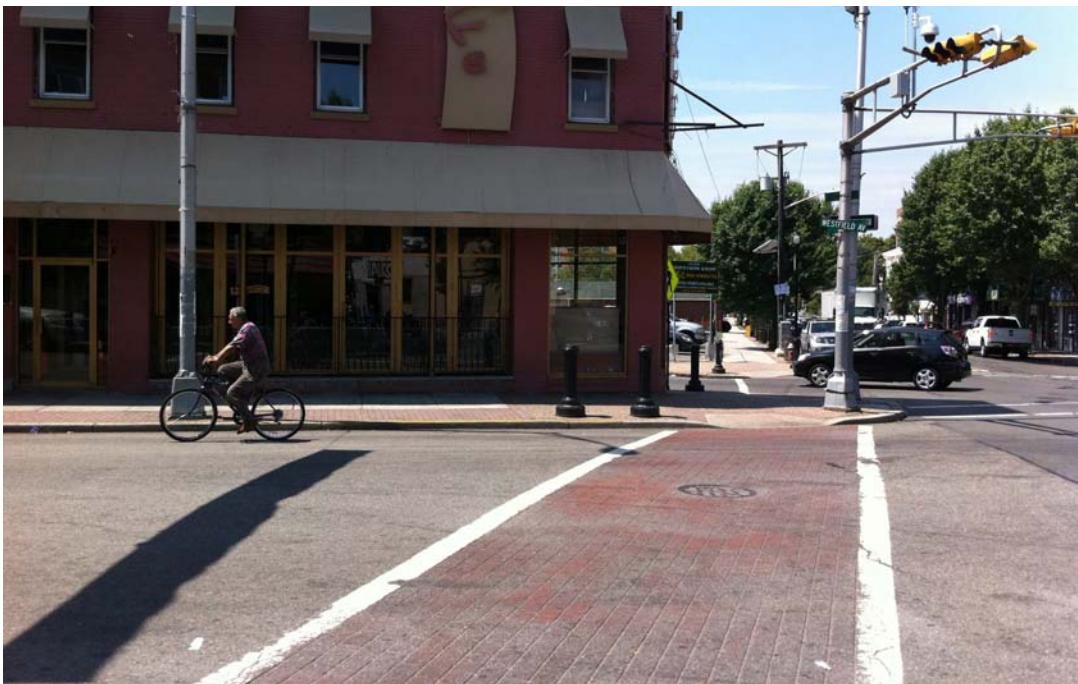
Figure B6 – Westfield Ave & Morris Ave – Minor improvements to the crosswalks (including ADA ramps) and pedestrian signage were made in downtown Elizabeth.

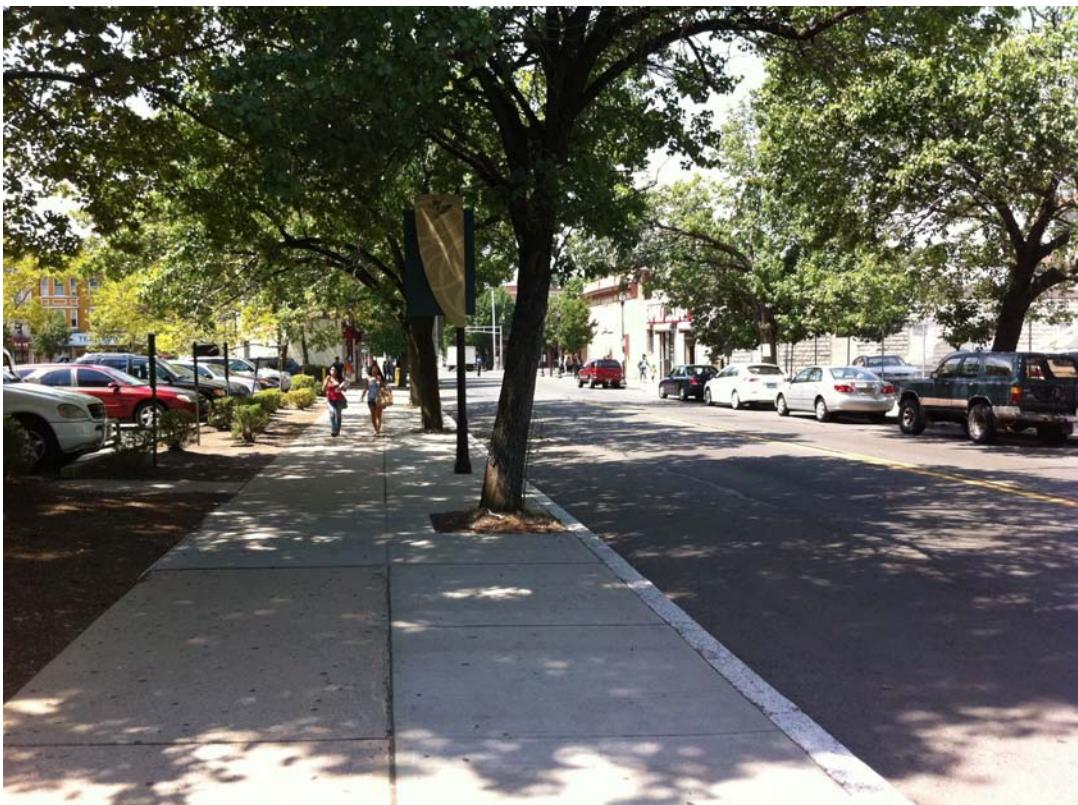
Figure B7 – Westfield Ave – Some areas of sidewalk and curbs were replaced, but not along the entire corridor

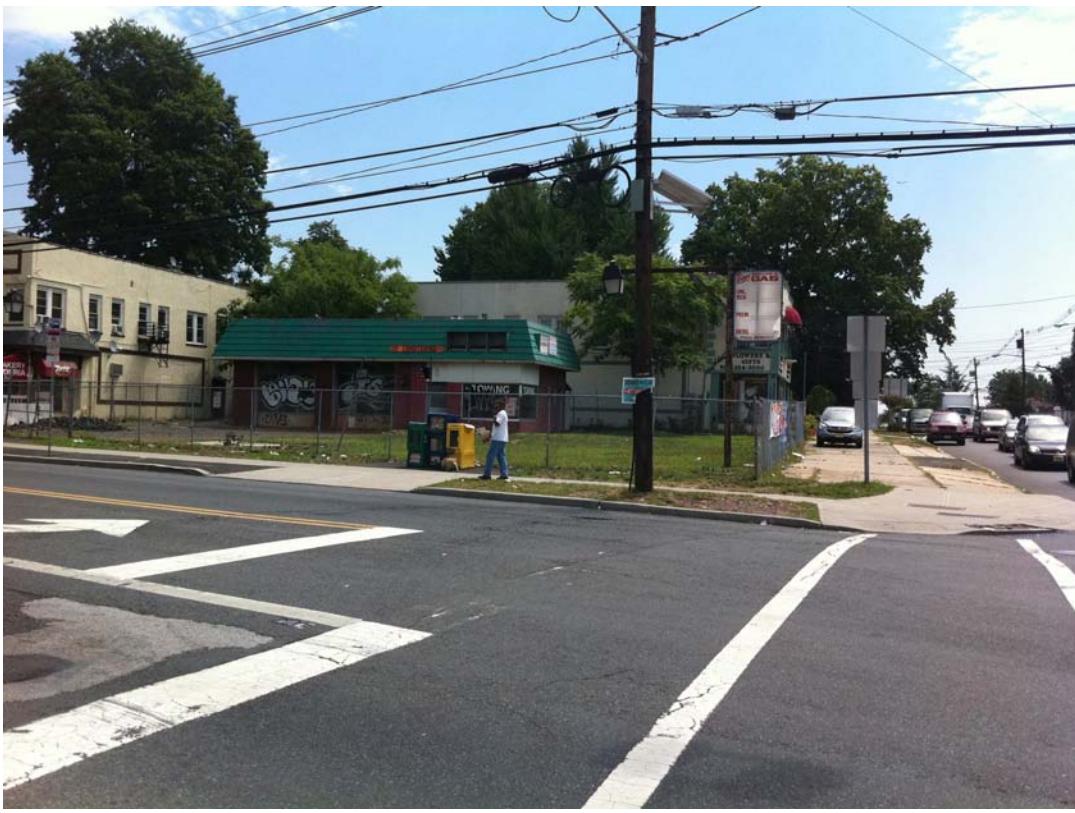
Figure B8 – Rahway Ave & Elmora Ave – Further down the corridor, similar improvements were made to the sidewalks and crosswalks, but only at major intersections.

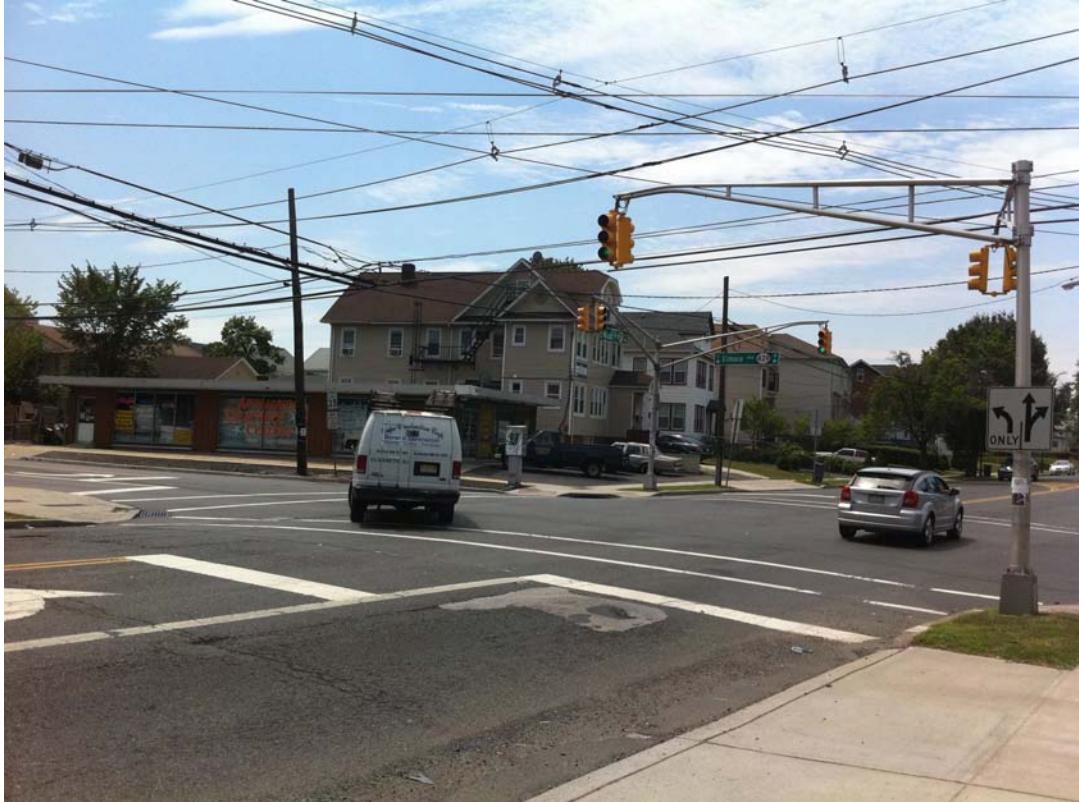
Figure B9 – Rahway Ave & Elmora Ave – No pedestrian crossing signals are in place along the corridor.

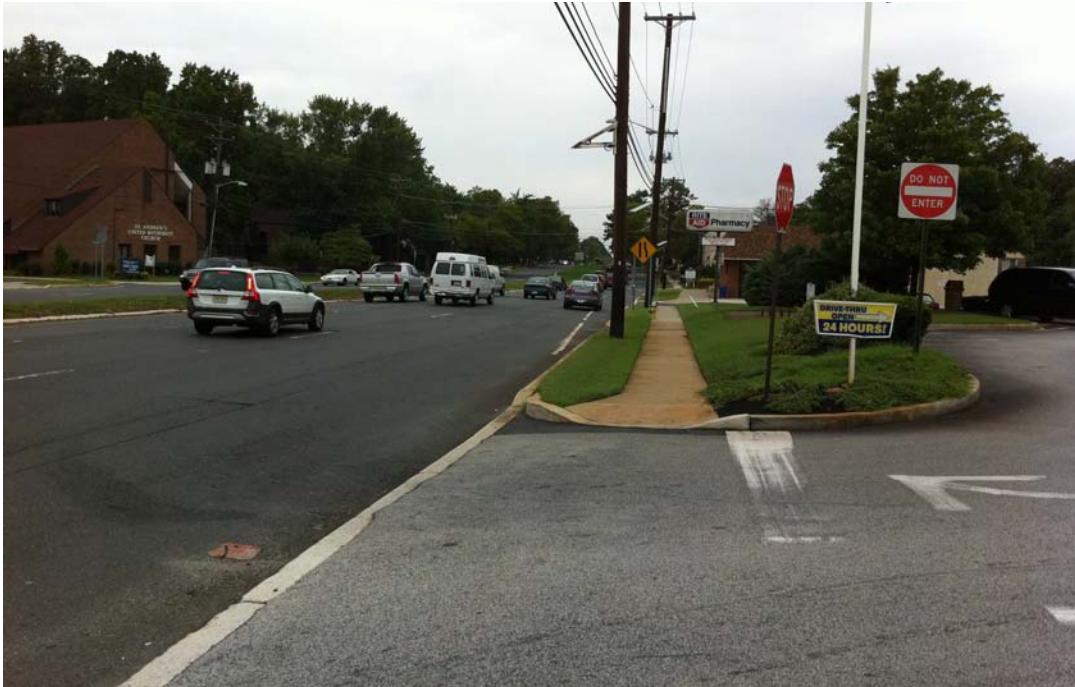
Figure B10 – Marlton Pike W near Route 41 – Very little improvement was visible along the entire Route 70 corridor. These improvements date back to 2006, so age may have taken a toll.

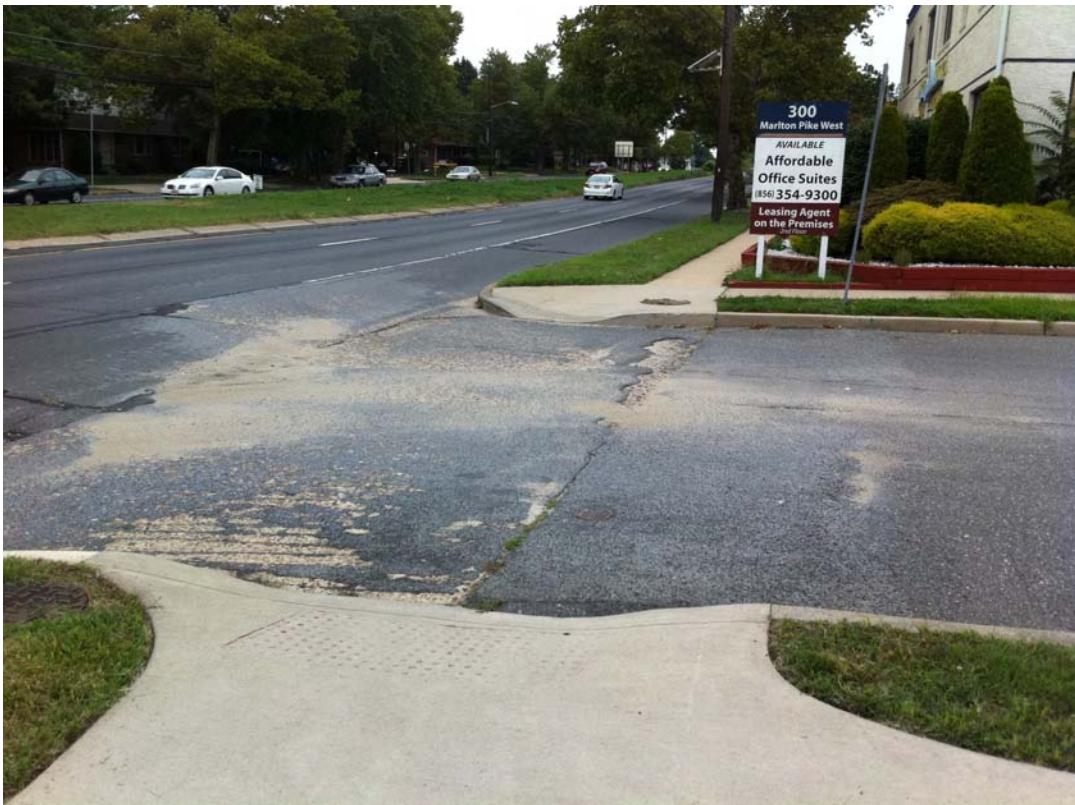
Figure B11 – Marlton Pike W near Route 41 – The entire corridor has narrow sidewalks and very few pedestrian crossings. Traffic volumes and speeds seem like a significant deterrent to pedestrian activity along this corridor.

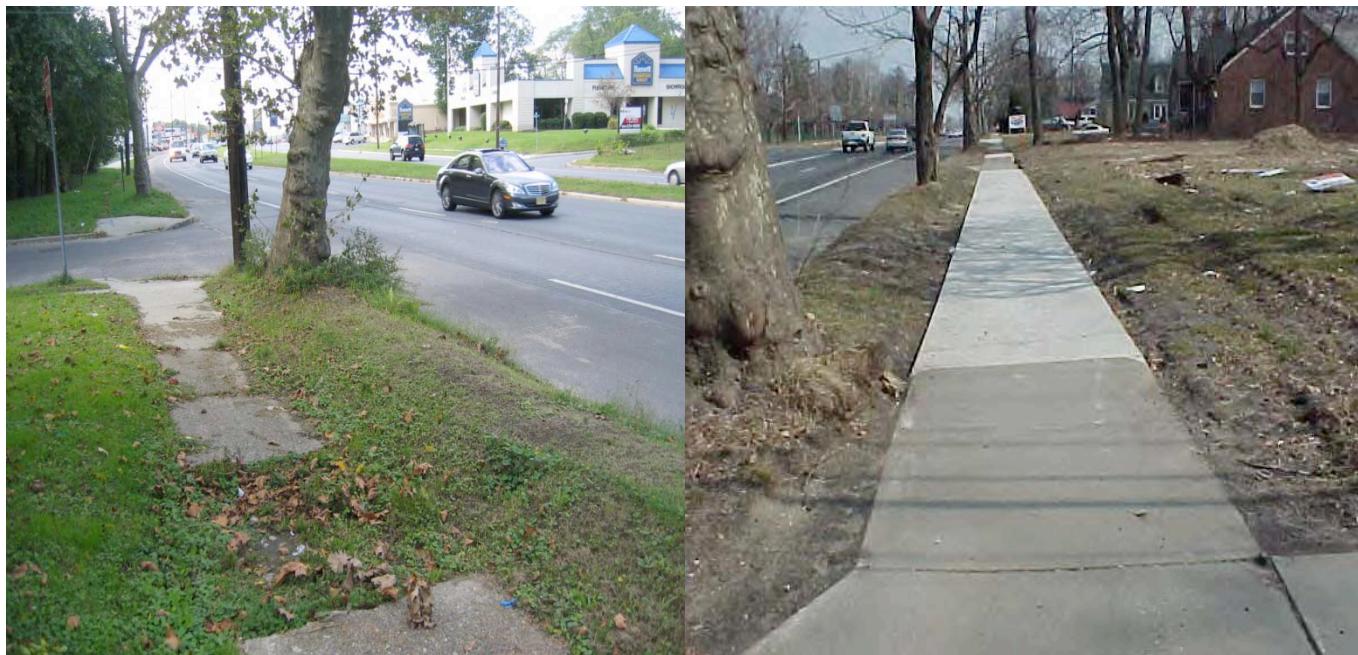
Figure B12 – Before and after photos of improvements along Route 70 (Unknown photo credit; NJDOT)
